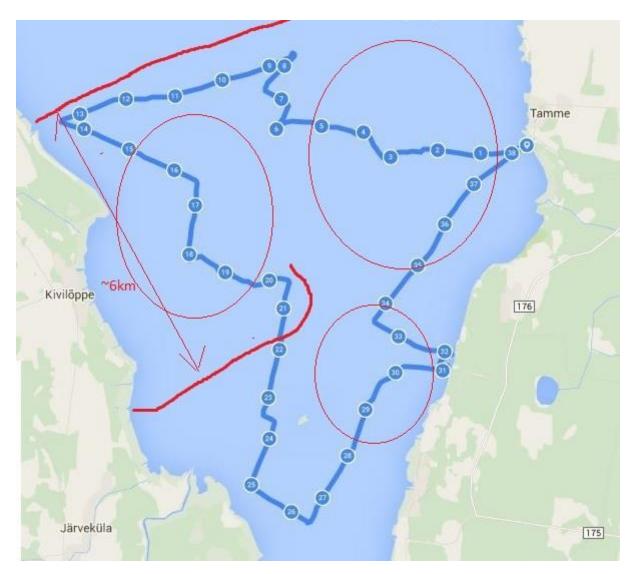
Northen crack(red line) runs across the lake and is about 1m wide. Southern crack runs to the middle of the lake and turns north, from there runs north about 1km, Crack is about 10-30cm wide.

Ice overall is hard and dry. At point 26 ice has no cracks but is a bit bumpier than in the north. Suitable race areas marked with red circles.

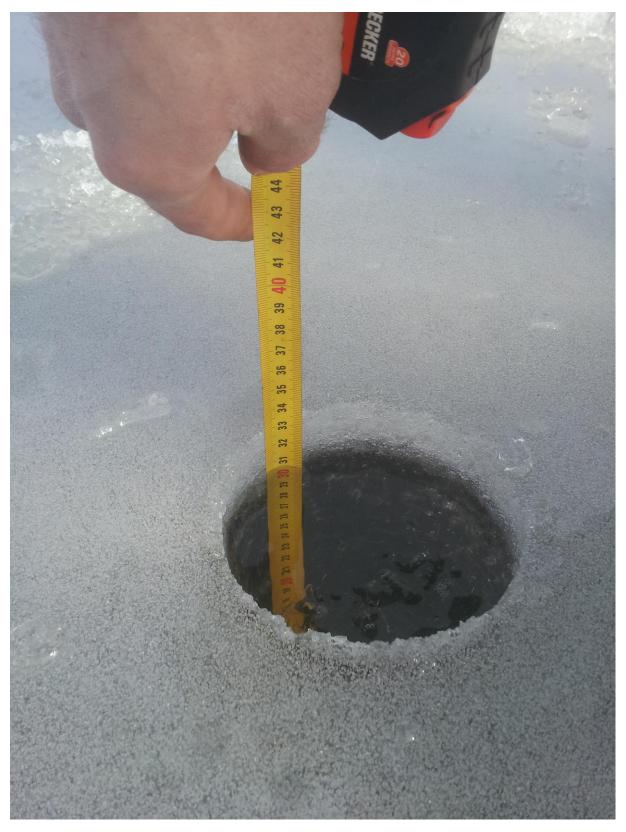
Point 1. Thickness 32cm
Point 3. thickness 35cm
Point 4. thickness 74cm (ridged ice layered ontop of each other)
Point 6. thickness 37cm
Point 13. thickness 23cm
Point 18. thickness 28cm
Point 22. thickness 26cm

Pic 1. Ice thickness at point 1

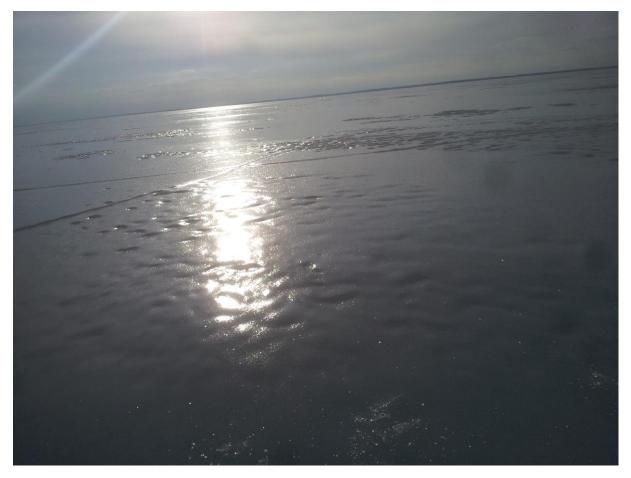
Pic 2. Ice overview at point 1

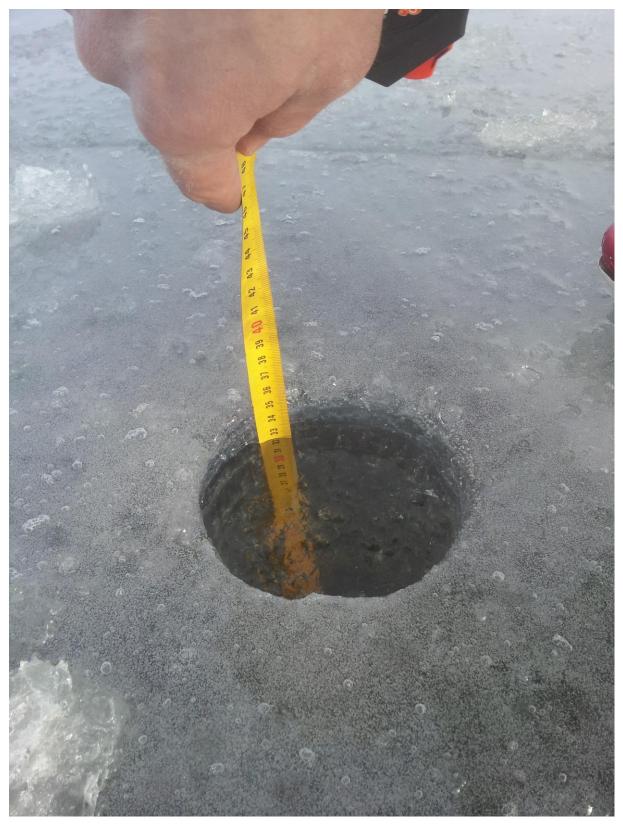
Pic 3. Ice thickness at point 3

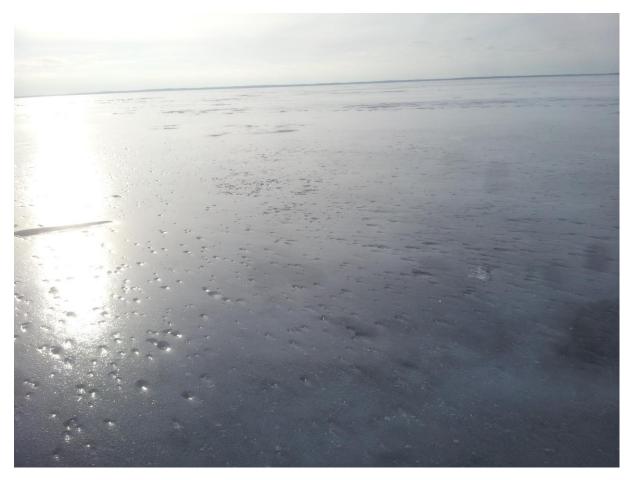
Pic 4. Ice overview at point 3.

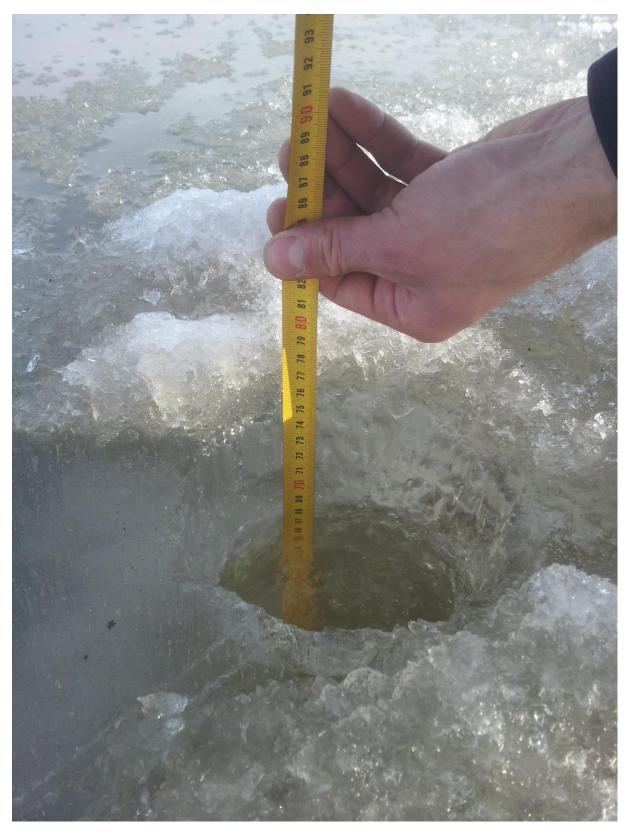
Pic 5. Ice thickness at point 4.

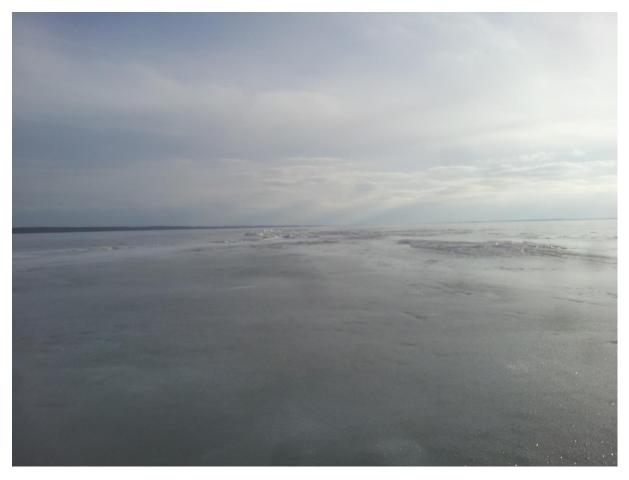
Pic 6. Ridged ice at point 4 (about 50mx50m)

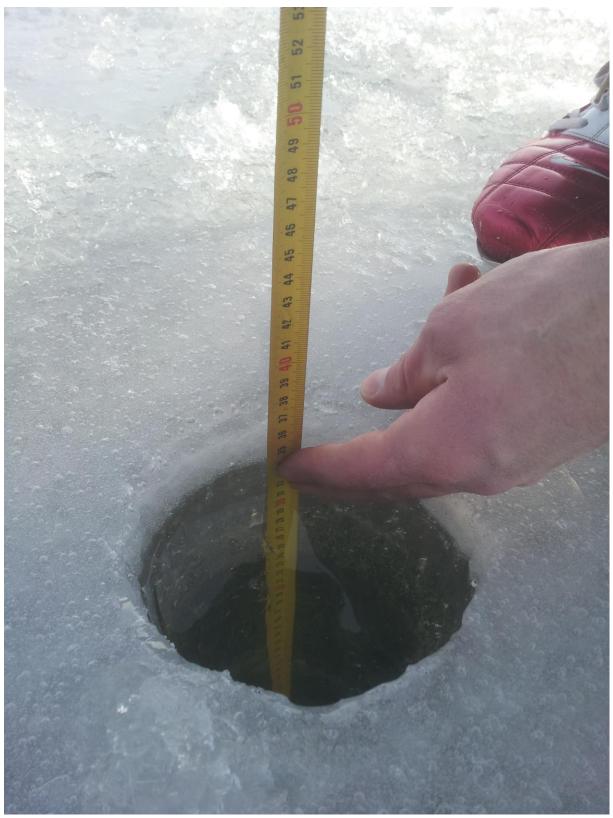
Pic 7. ice thickness at point 6

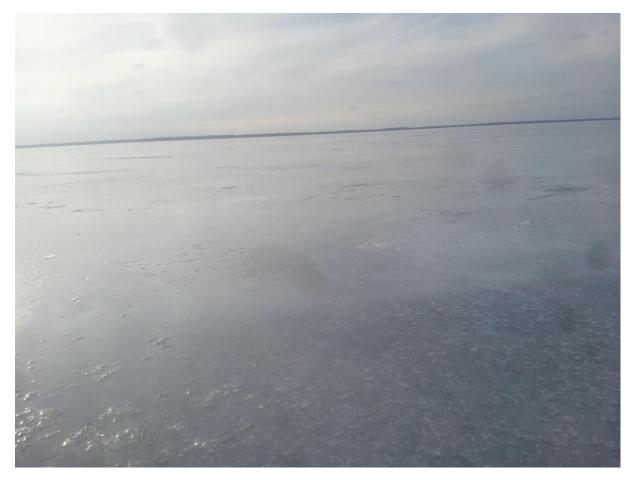
Pic 8. ice overview at point 6.

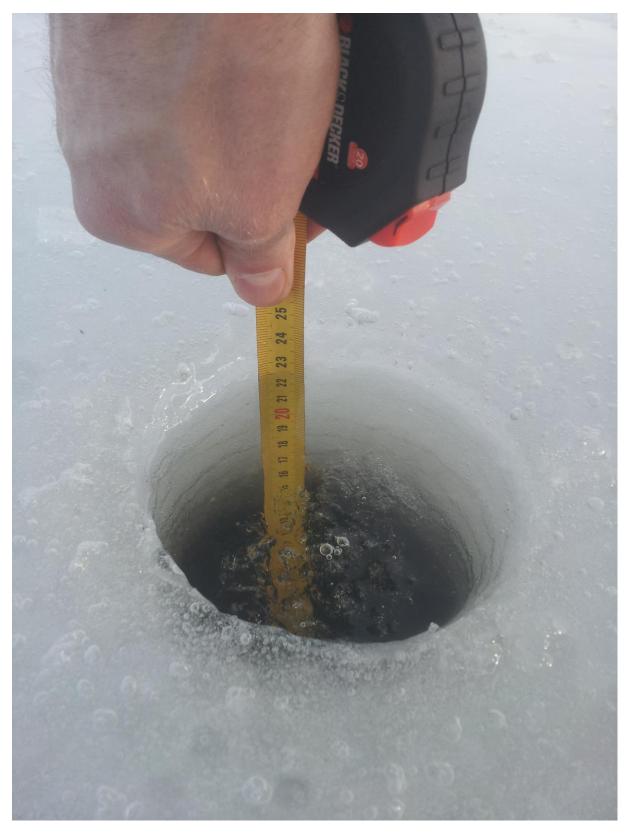
Pic 9. Ice thickness at point 13.

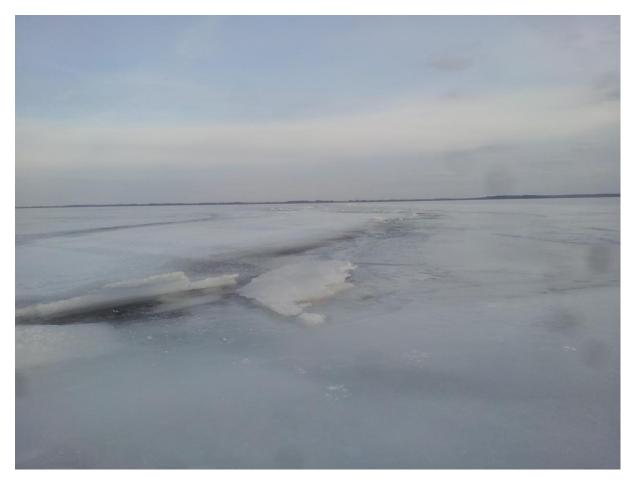
Pic 10. Ridgec ice at point 13.

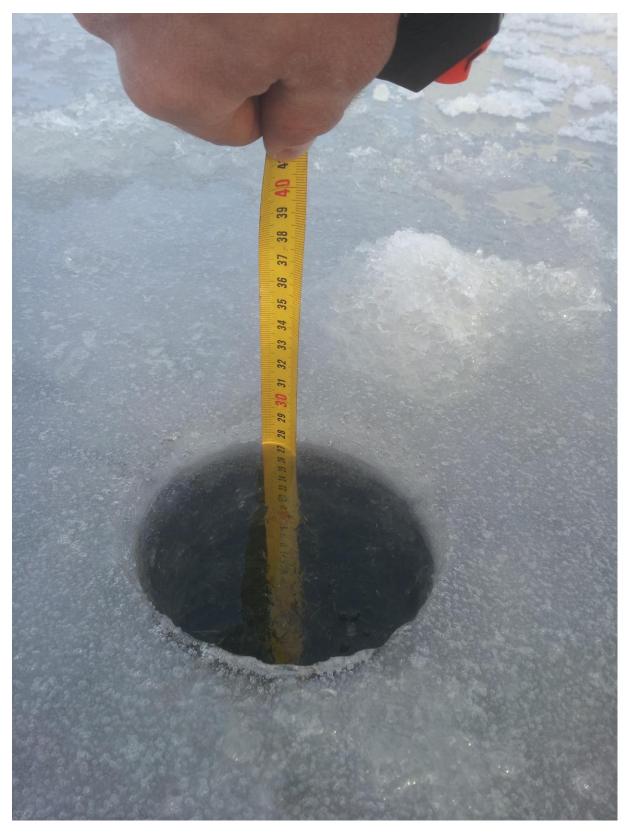
Pic 11. Ice thickness at point 18

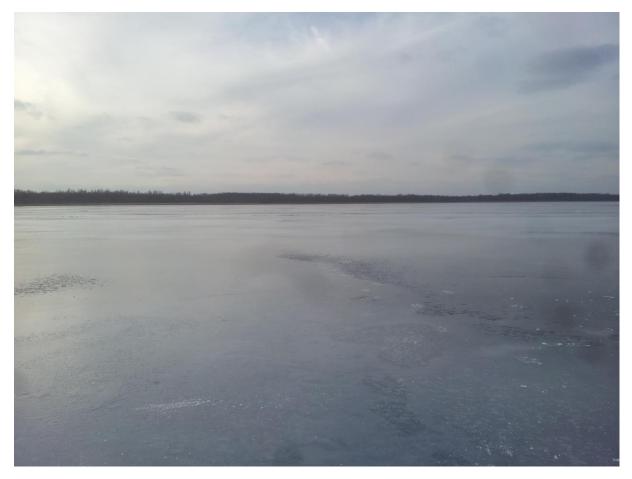
Pic 12. Ice overview at point 18

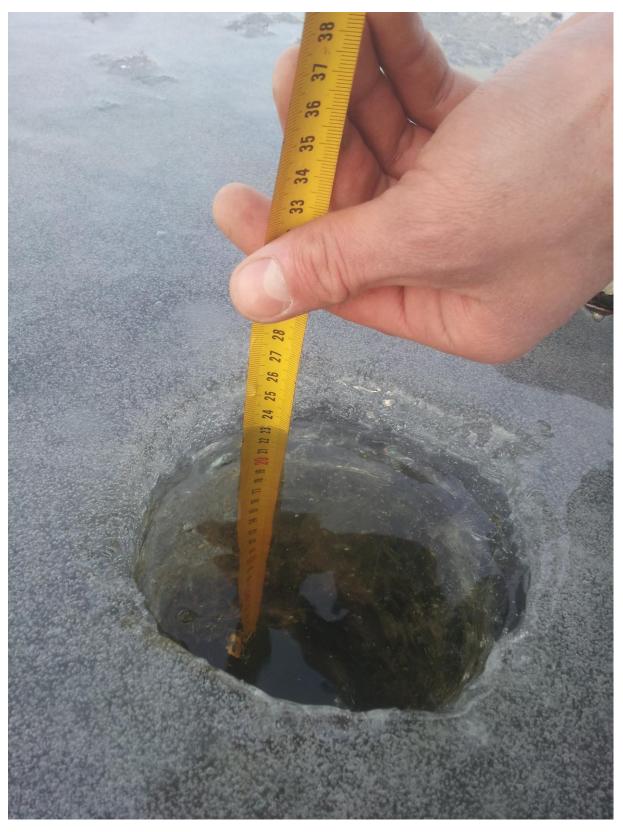
Pic 13. Ice thickness at pint 22

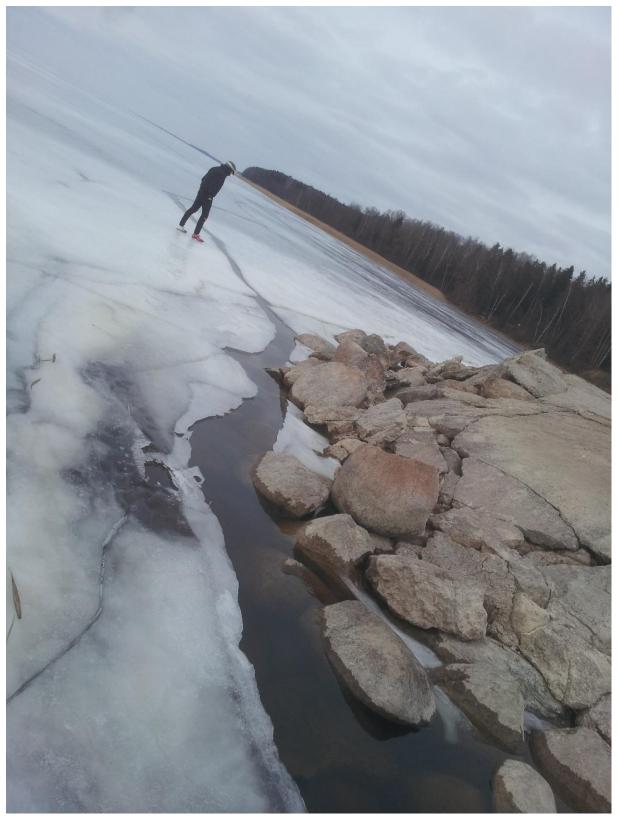
Pic 14. Jetty at Limnoliigia jaam (crack ends in about 100m)

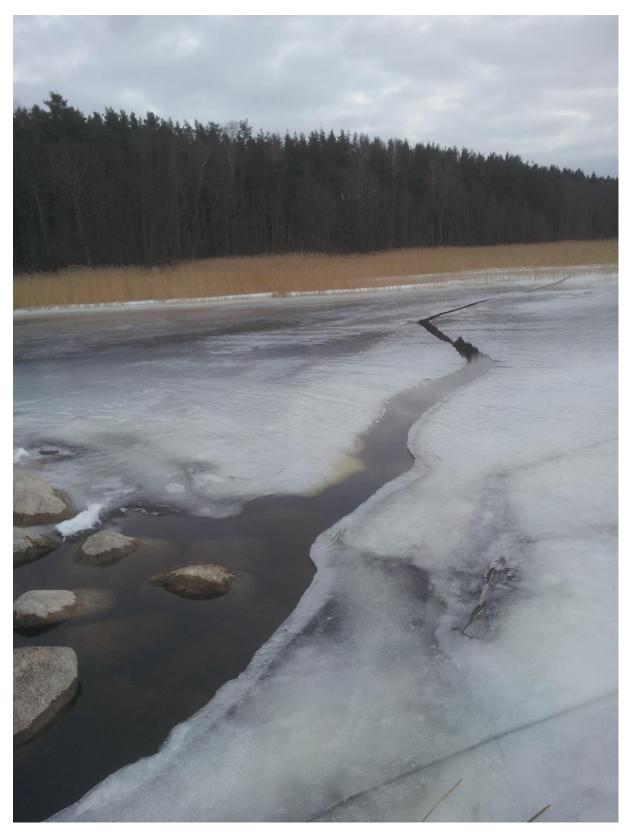
Pic 15. jetty at limnoloogia jaam

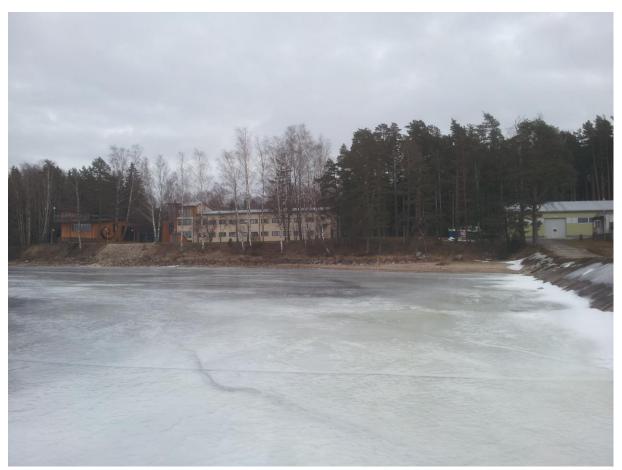
pic 16. ice overview at Limnoloogia jaam
