DN TECHNICAL COMMITTEE SUMMARY REPORT  
ICEWISE PLANK TIMELINE AND FINDINGS  
NOVEMBER 13, 2022

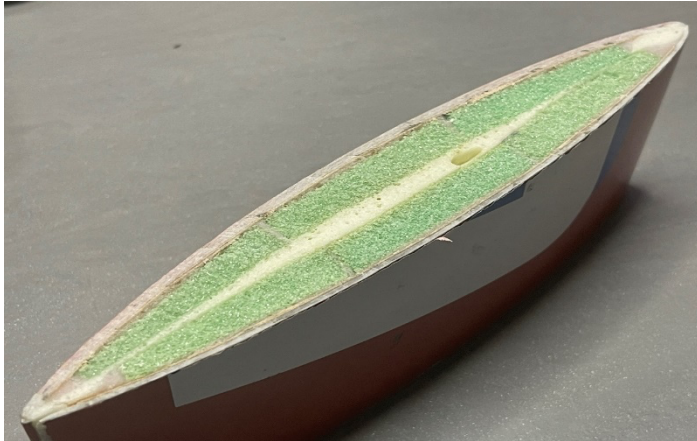
**MARCH 2022:** Initial broken Icewise plank found with illegal foam core.

This is actual crosse section of the failed plank from the Western Championship March 2022

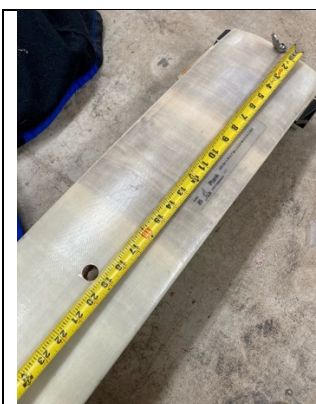
Picture 1

Pic 1 shows where the test hole is located.

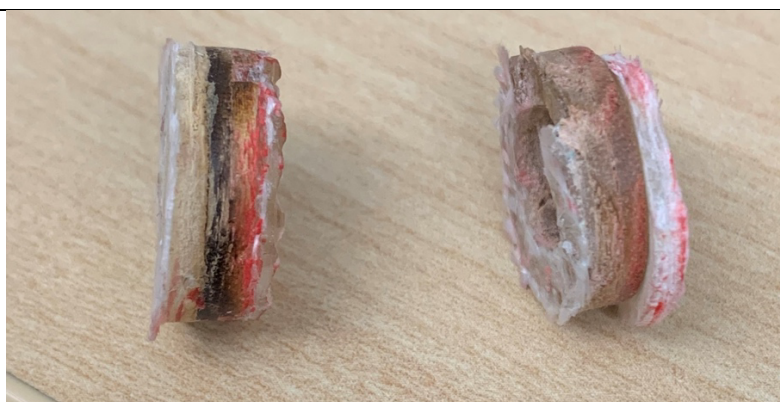
Picture 2

Pic 2 shows the layers. The plank is hollow where the test hole was cut. The section on the left is still glued together and consists of roughly 2mm of glass, 3.5mm of wood, and a lightweight layer of what looks like resin rich woven fiberglass. The section on the right was delaminated but similar construction.

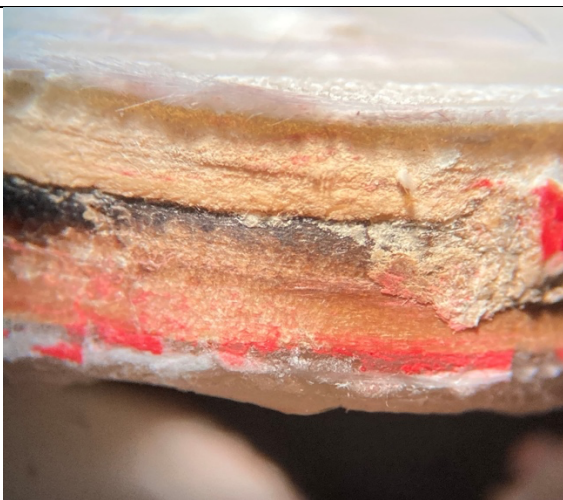
Picture 3

Pic 3 shows the left side laminate from pic 6 closer up. The red is paint from the hole saw.

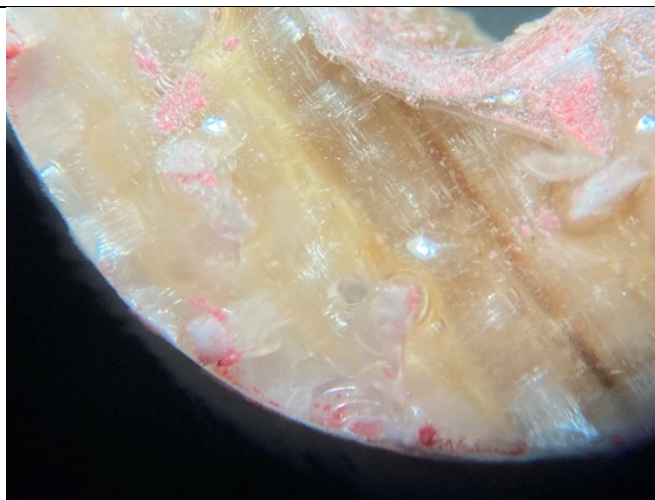
Picture 4

Pic 4 shows the resin rich woven layer on the inside of the left side section from pic 2.

Picture demonstrates woven fiberglass laminated to the inside of the wood on both halves. This design fails to comply to the rule: B. Runner plank interp. 11/30/98: ... *Internal fiberglass reinforcement is not allowed.*

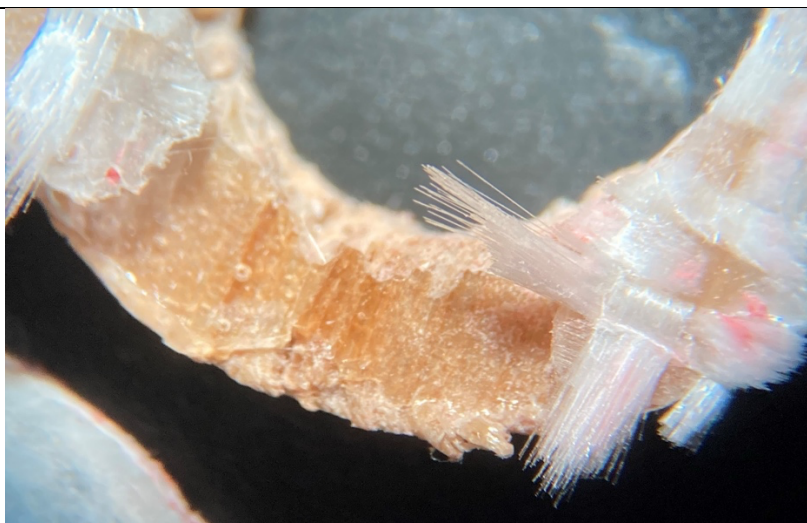
Picture 5

Pic 5 shows the woven layer on the inside of the right side section from pic 2.
